ARCHITECTURAL IMPACT of 19th-CENTURY FIRE REGULATIONS: A Case Study of New York Tenement Houses

Research Article

Abstract

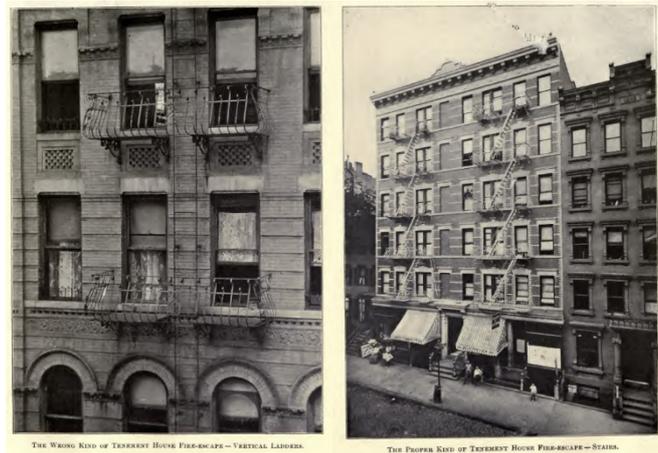
In the 1890s, there were 37,358 tenement house units in the Lower East Side, with around two-thirds of the population (approximately 1.2 million people) living in these tenement units. Due to the rapid population growth, additional construction within parcels became evident, with buildings occupying around 90% of the parcel area. It has been documented that 2,391 of the 37,358 housing units were comprised of additional structures built in the rear courtyards. The new constructions carried significant risks in the event of a fire disaster. The 1901 law, known as the New York State Tenement House Act of the Progressive Era, prohibited the construction of dumbbell-shaped buildings and established optimal design conditions for tenement housing. Additionally, the legislation mandated regulations concerning the design and lighting of staircases and corridors, particularly in relation to fire escape routes. The law required that fire escape routes be arranged on both sides of the building, providing access from all units to the ground. Moreover, fire escape stairs had to be open steel/iron staircases on the facade, interconnected between floors via balconies (Figure 14), (DeForest & Veiller, 1903b; p.170).

Figure 14. Fire escape balconies before the 1901 law and “Z-shaped metal stairs” after the act. (DeForest & Veiller, 1903a; p.278 & 287)

It was explicitly stated that, prior to this law, buildings constructed earlier should also have fire escape staircases added, providing access to each apartment. It was also noted that wooden balconies or staircases would not be considered part of the fire escape route and must be replaced with steel or iron counterparts (DeForest & Veiller, 1903b; p.173).

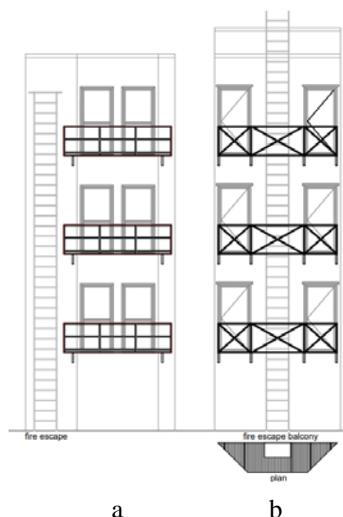
In accordance with the latest regulation, fire escape stairs that are fixed, located at the balcony’s edge, and at a specific distance from the balcony are no longer considered suitable for use during a fire incident because they can hinder escape speed. Such stairs are only permitted in buildings with a small number of occupants and low-rise structures, as illustrated in (Figure 15-a). Conversely, the straight inter-floor staircase system was prohibited by the 1901 law as it poses difficulty during fire emergencies, particularly for children and women in panic situations, as shown in (Figure 15-b).

Figure 15. (a) Fixed fire escape staircase model on the balcony edge (Andre, 2006; p.144), and (b) Fire escape staircase model connecting between floors through balconies (Andre, 2006; p.133)
